Continuity and change in Dutch shipbuilding in the Early Modern period. The case of VAL7 and the watership in general.

Joep Verweij, Wouter Waldus & André van Holk

Abstract

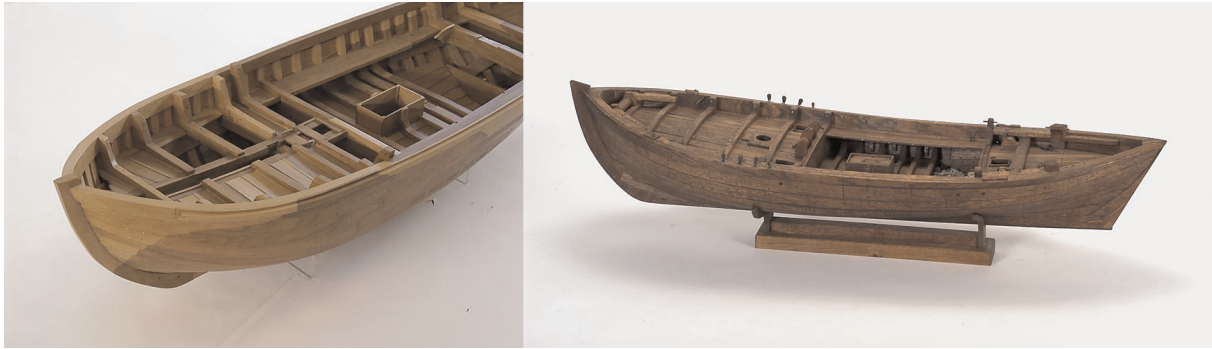
Figure 2 Archaeological reconstruction models of the watership hull. Left the lap-strake model of ZM22 and right the flush hull model of OW10. (Photo Cultural Heritage Agency dept. Lelystad).

The models (fig. 2, fig. 11) show a sharp underwater hull fore and aft while in between there is very little deadrise. From the keel upward the rounded underwater hull is curved in an S-shape. This is a medieval underwater hull shape typical for the cog-like ships of the Hanse period. The cog design disappeared in the Early Modern period. There was a tendency in the Zuiderzee area to resort to flat bottomed ships with side-mounted retractable leeboards. The watership however retained the medieval hull shape over its life trajectory.

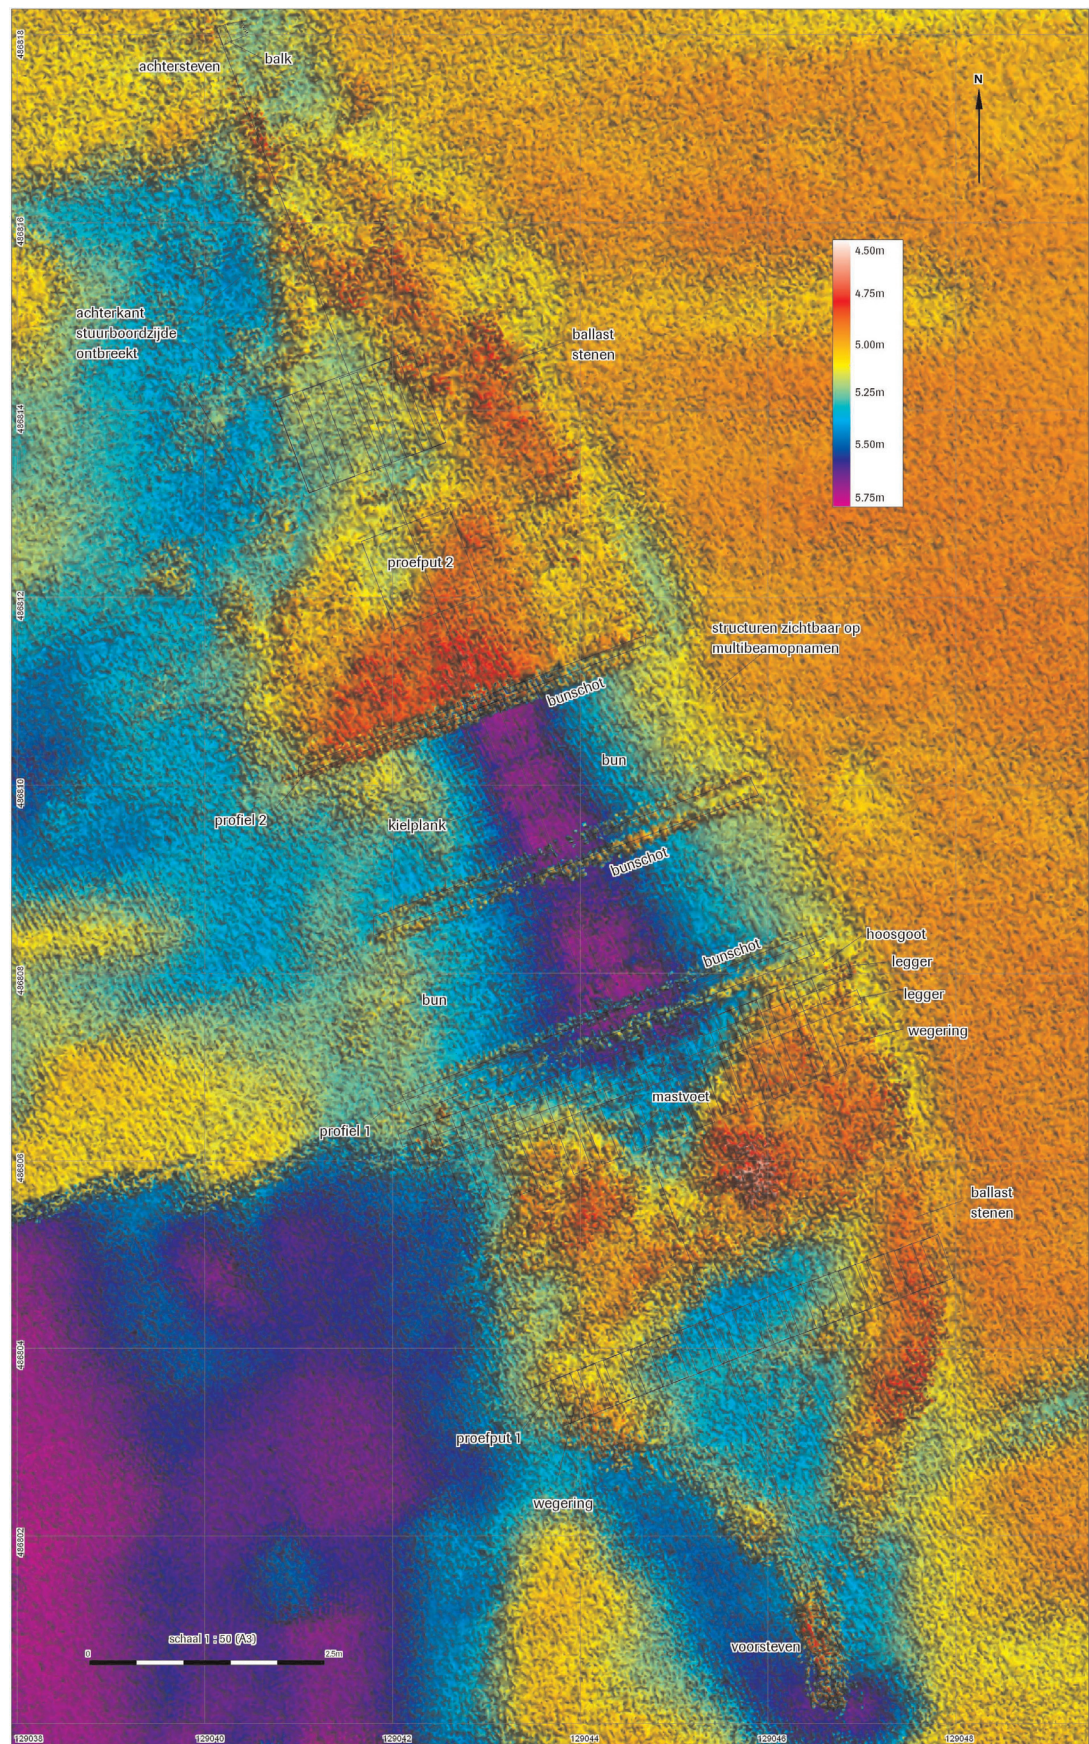
Figure 4 This multibeam image clearly reveals the shape of the hull. The fish well area in the middle is divided into two sections, and the bow area is located at the bottom of the image. The dark square left bottom is the spot where dredging stopped (Waldus 2010).

The unknown wreck was reported immediately as it may have historic value, but clearly was an obstacle in the future shipping lane. Authorities subsequently ordered an onsite dive inspection and a geophysical survey to be executed. Multibeam sonar images revealed the contours of what appeared to be a watership (fig. 4).

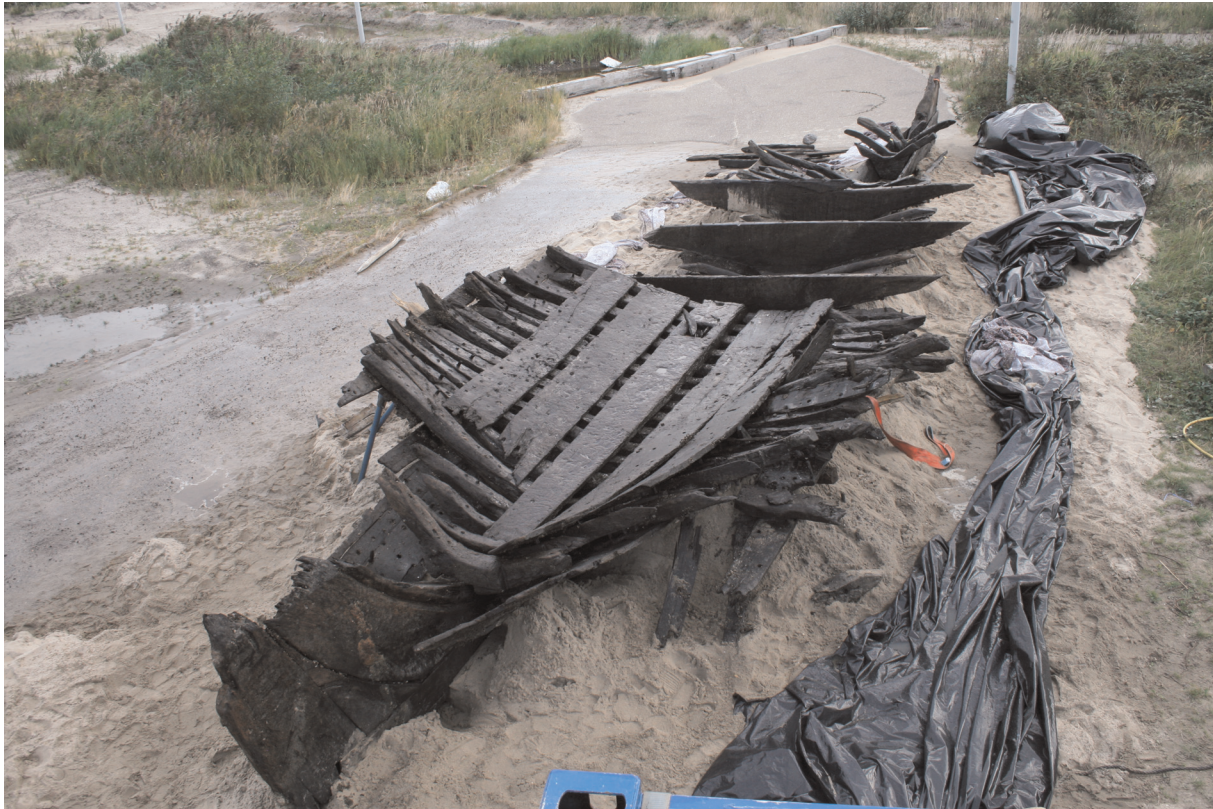
Figure 5 The VAL7 wreck lifted ashore for documentation purposes (Waldus 2010).

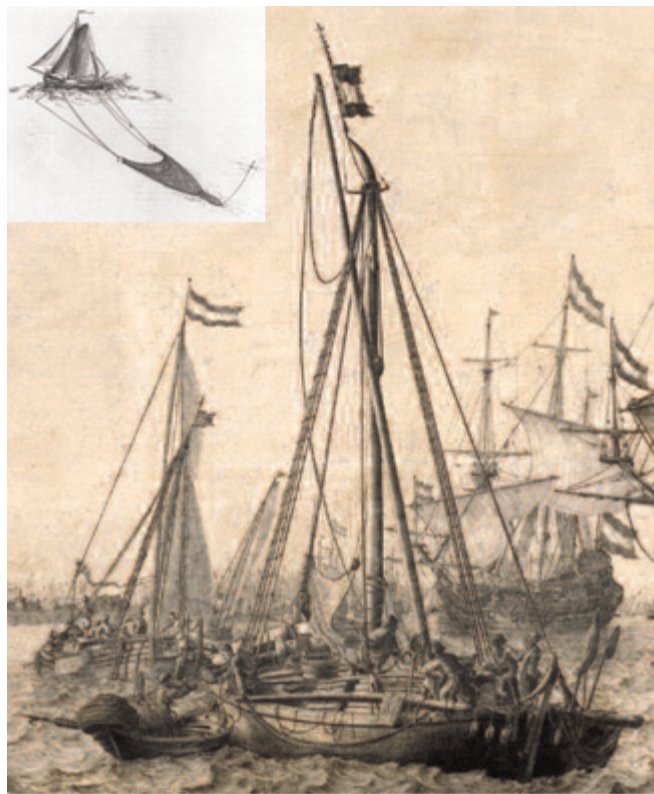
Figure 6 Watership as trawl net fishing vessel. In the drawing the ship is offloading fresh fish into a small boat at Amsterdam roads for the local market. The long pole on the side, the ropes and net weights (rounded stones) dangling off the side are part of the fishing equipment. (Detail from a pen drawing by Ludolf Backhuysen c. 1660 (collection Maritime Museum Amsterdam).

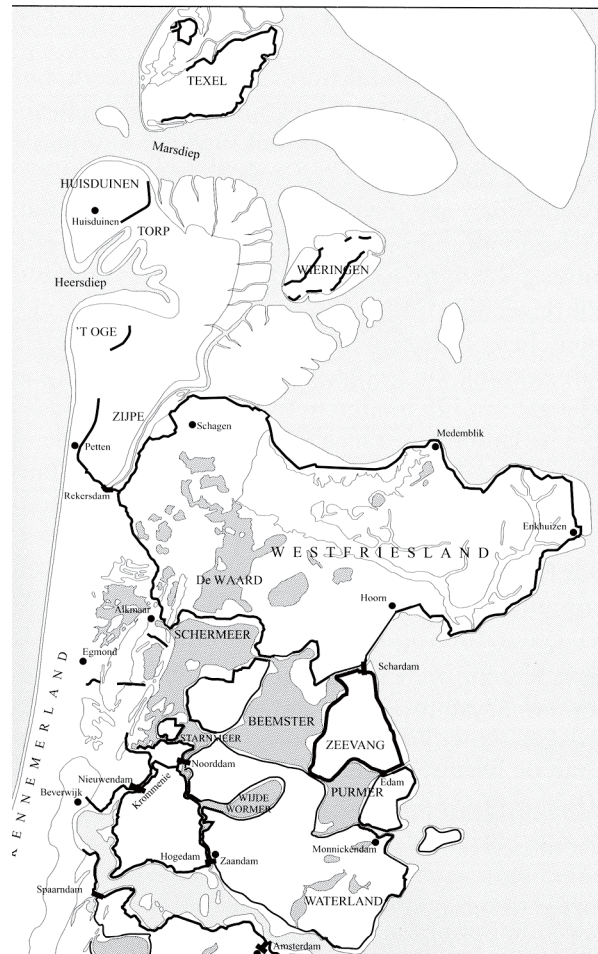
Figure 7 The present-day province of North-Holland in 1350. Each opening to the sea has a dam. The black lines represent the layout of the dyke system. (Boschma-Aarnoudse, 2003, 41). The lakes are turned into land between 1612 and 1624.

Neither archaeology nor archives have revealed a clue yet that waterships were ever constructed outside the region that is nowadays called the province of North-Holland. Hence the scope is limited to this region (fig. 7). The period in which the watership occurs spans at least four centuries. Its genesis and original appearance remains obscure since fourteenth and fifteenth century waterships did not show up yet in the archaeological record. Its demise, well known from archival information, is 1827 when the Dutch Navy decommissions the last watership from the service as a tug (Koningsberger & Oosting 1994; Boven & Hoving 2009, 55).

The timeframe in which the trawling function is scaled up in the early sixteenth century, coincides with the first observed design change in the previous paragraph in which watership dimensions increase with more workspace and fish well volume. However, the watership possibly retains its postulated long distance transport function throughout the sixteenth century. Three wrecks (ZN74-1, NP40, NR13) from this period appear to have their water inlet holes in the fish well plugged thus isolating the inner fish well space from the outside. An explanation is that fresh-water fish, transported in a saline environment, will die in the fish well. The same is true when transporting sea fish in a fresh-water environment. Even eel, adapted to both environments, could die if its skin is damaged. Other explanations exist, like the use of the watership to transport saline water to the salt factories onshore (Van Holk 1994, 4). Early in the seventeenth century the watership lost its long distance transport function. This is indicated by early reports of the *Friesche palingschuit* exporting life eel from the Frisian lakes to London (Haalmeijer & Vuik 207, 59). The year 1616 is mentioned, which coincides with large-scale windmill-driven land reclamation projects in North-Holland (fig. 7) at the expense of the local eel trade.

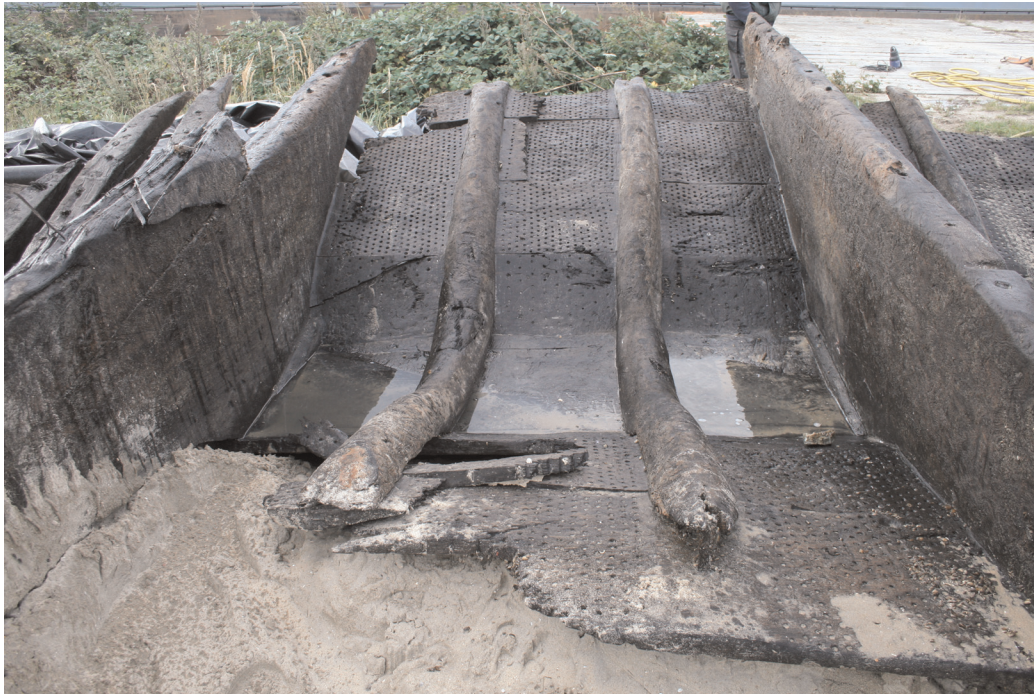
Figure 8 One fish well compartment with relatively few rounded timbers and numerous water inlet holes in VAL7 (Waldus 2010). This is similar in all waterships. The smoothly finished frame construction served the purpose of maximising space and minimising damage to the fish swimming inside the fish well.

All waterships have in common that the framing system in the fish well was not robust (fig. 8). Heavy bulkheads compensate for the loss of lateral strength in the fish well area.

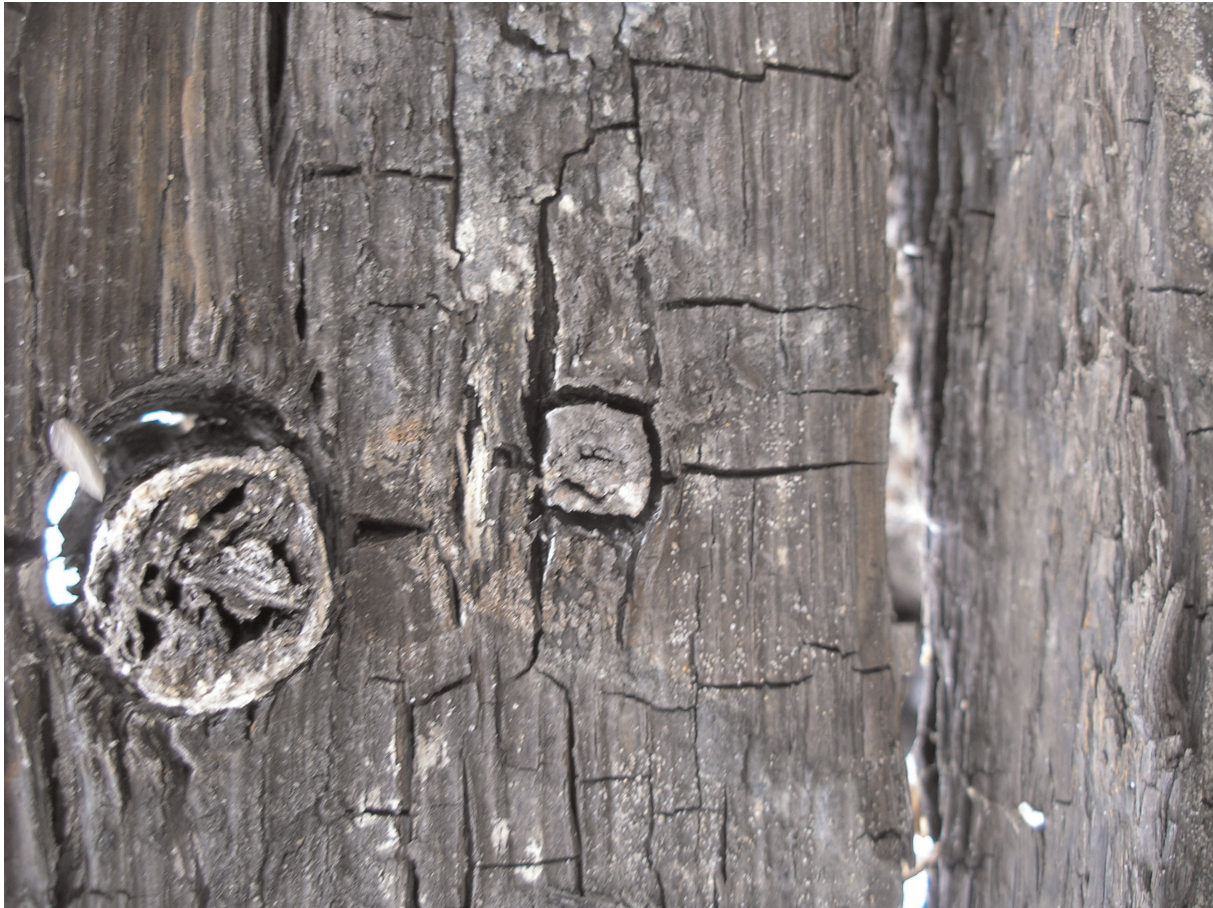
Figure 9 The square small spike plug fills a former nail hole in a starboard strake. Its dimension is 0.5 x 0.5 cm. Left of the spike plug a treenail is protruding. (Waldus 2010).

The flush hull construction of the younger waterships had the characteristics of the Dutch flush style of shipbuilding. Maarleveld introduced the term *Dutch flush* in relation to shipbuilding developments in sixteenth century Holland (Maarleveld 1992). He refers to large sea-going vessels and not locally operated ship types like the watership. The Dutch flush technique is perceived to be a variation to the Northwest-European tradition of shipbuilding, meaning that the shipwright had the *bottom based* philosophy in mind and used clamps in a *shell first* approach. New is that the Dutch flush ships in general have well integrated flush sides, as opposed to having lap-strake sides. As described in paragraph 4, the VAL₇ wreck actually displayed the features indicating that a *shell first* construction approach was used in a flush built watership (fig. 9). Also the sides were well integrated in the hull.

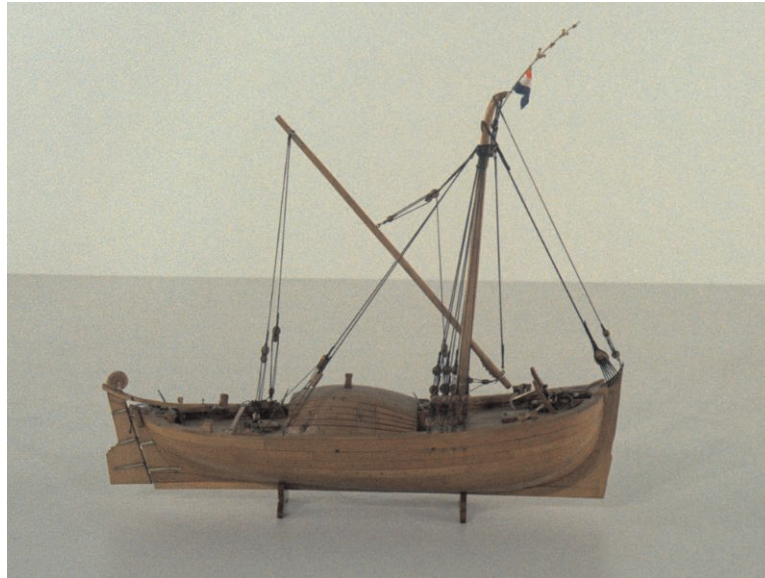
Figure 11 Shipmodel of a Marker watership from around 1800. Characteristic is the high bluff bow, the low stern, the rounded deckhouse and the short spritsail mast tilted forward with rounded mast top. (Collection Maritime Museum Rotterdam model M199).

The internal layout of the watership and the equipment on deck did not change over time. This is apparent from a scan through the wreck data, and can be visualised when the archaeological models (fig. 2) are compared to an early 19th century model of the watership (fig. 11).

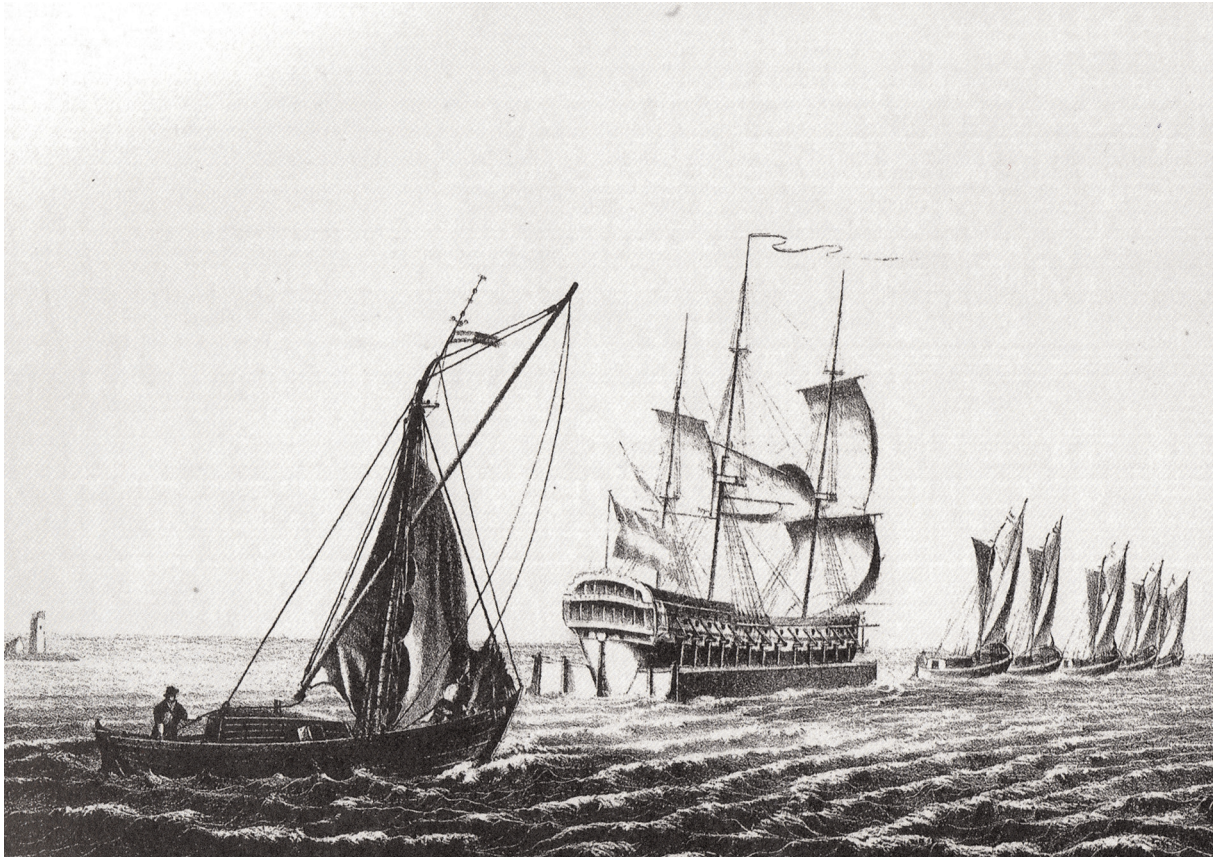
Figure 12: Five waterships towing an ocean-going ship in a shipscamel. The function of the camel was to decrease the draft of the ship. (Boven & Hoving 2009, 42).

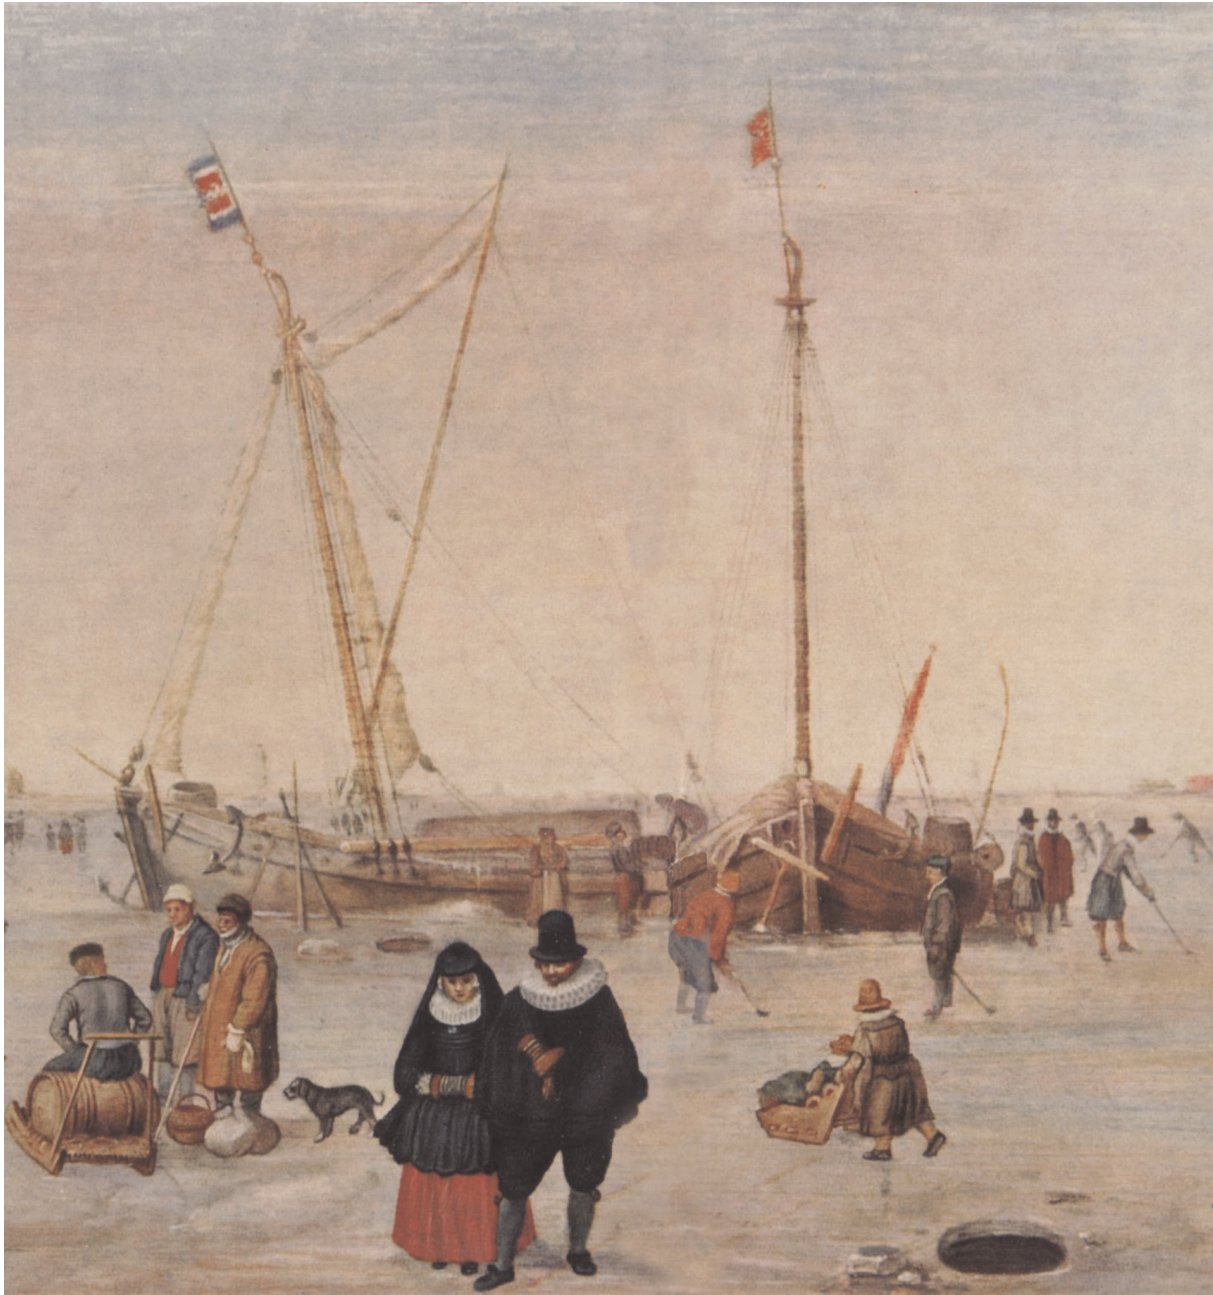
Figure 13 Detail from a painting made by Hendrick Avercamp between 1600 and 1634. The ship to the left has a flush hull, the other ship is lap-strake constructed. (Museum Boymans van Beuningen, Rotterdam, inv. no. 2482).

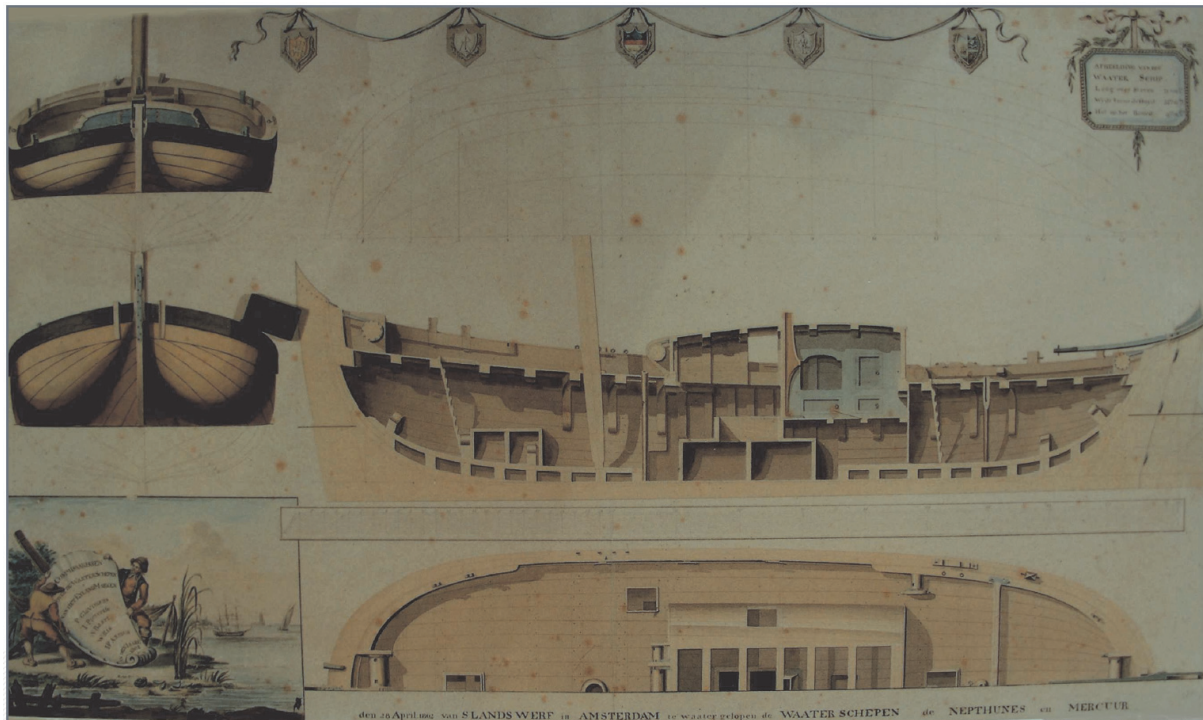
Figure 14 Construction drawing of a watership. More sober drawings of the same design still exist. This drawing probably served as a special issue made when two waterships were launched on 16 april 1802 from the Navy yard in Amsterdam. (Collection Maritime Museum Rotterdam inv. no. T2311).
